Manhole Inspection Summary

Manhole # S35K__011MH

Insp Date: **12/29/08 12:23 PM**

Location Address: **300 light st**

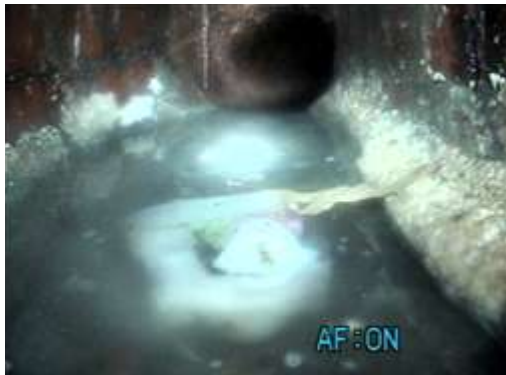
MISC

channel debris

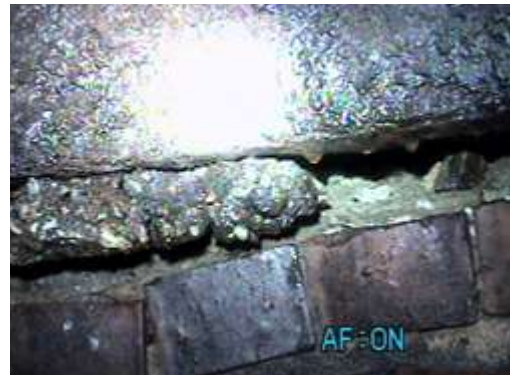
Defect 2

Frame Offset: **0** (in.) Condition: ☐ Sound ☐ Cracked ☒ **Leaks**

Condition: ☐ Sound ☐ Cracked ☐ Root Intrusion ☐ Loose Brick ☒ **Deteriorated**

Chimney deteriorated, frame leaks

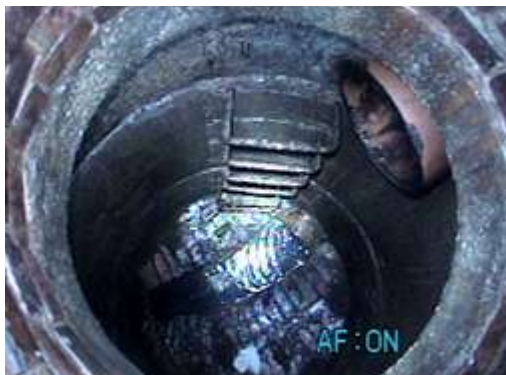
Defect 1

Steps Count: **6** Missing: **0** ☒ **Corroded**

steps corroded

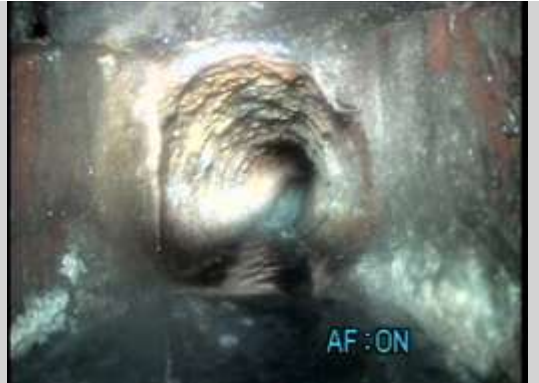
12 O'Clock Outflow

10 in. Circular Gravity Sewer
Pipe Out @ 12 O'Clock

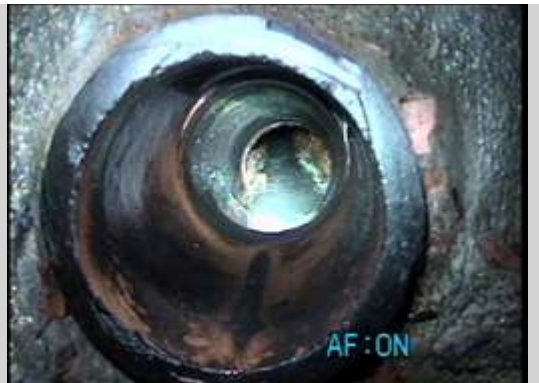
6 O'Clock Inflow

10 in. Circular Gravity Sewer
Pipe In @ 6 O'Clock

Drop In @ 6 O'Clock
